AN INVESTIGATION INTO THE EFFECTS OF
AN HERBICIDE ON HISTORIC MASONRY
MATERIALS

Catherine Camille Dewey

A THESIS

Historic Preservation

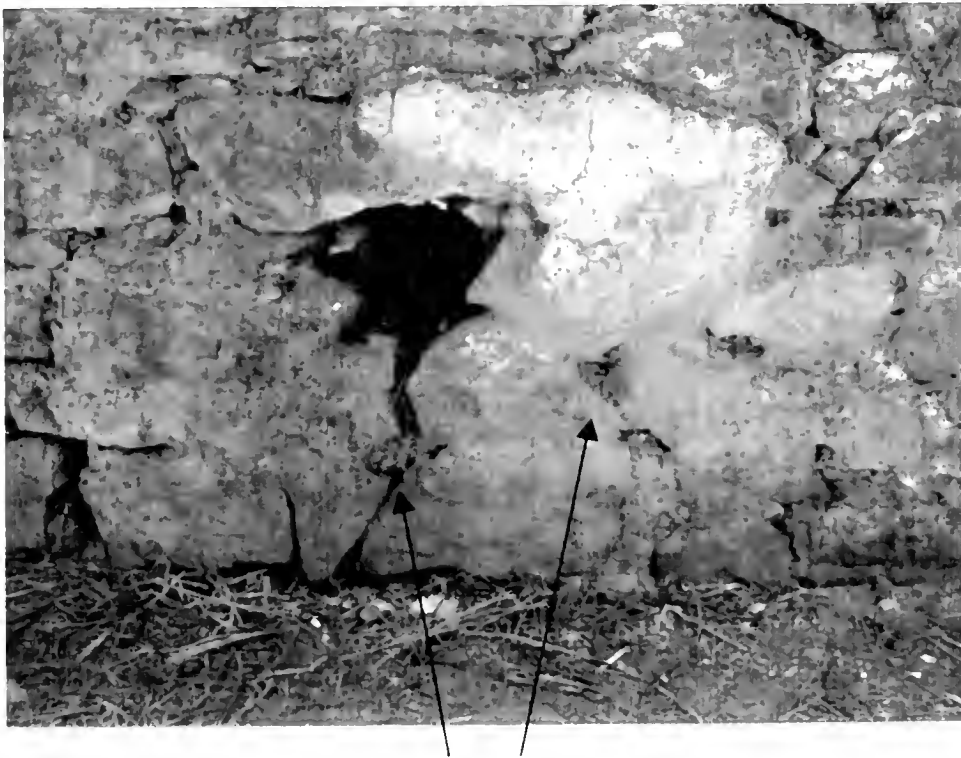
Figure 1: Small plants growing in joints

While the above ground elements cause little direct damage other than erosion by rubbing stems or leaves,⁹ and discoloration from fallen and decayed organic matter, the root system can be quite harmful. Plants with large root systems are obviously the most damaging to structures allowing the development of numerous places for mechanical and chemical deterioration.¹⁰

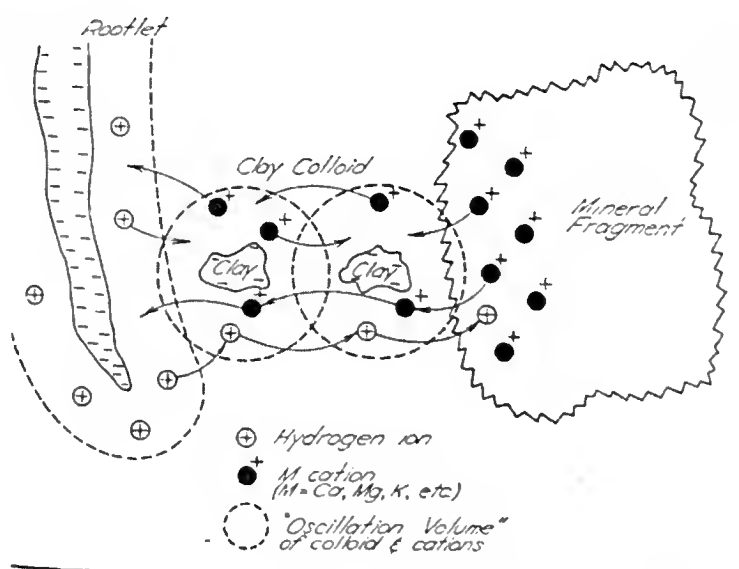
Figure 2: Diagram of hydrogen-mineral exchange between plant roots and mineral (reprinted from Keller and Frederickson)

The process of chemical weathering, as related to plant activity, has been investigated and described by Keller and Frederickson. The root surface is "enveloped by hydrogen ions which are chemically aggressive to minerals due to a greater chemical potential energy arising from their high electrical charge per unit volume."²⁰ As the root advances into a void of the rock, this characteristic destroys tangential mineral compounds. The hydrogen ions invade the fractured lattice at the crystal boundary and displace sodium, calcium or potassium, which are absorbed by the root as nutrients.²¹ As the plant removes these minerals and replaces them with hydrogen ions at the surface, it restores the original

concentration of hydrogen ions.²² The replacement of sodium, calcium or potassium ions by H^+ ions destroys the stability of the lattice because of the difference of coordination between the H^+ ions and the metal cations.²³ Hydrogen ions are easily exchanged for nutrients because of their small size and their high-energy chemical properties arising from a large charge for a small particle.²⁴ Carbonate materials tend to be more susceptible to weathering because of their sensitivity to acid attack.

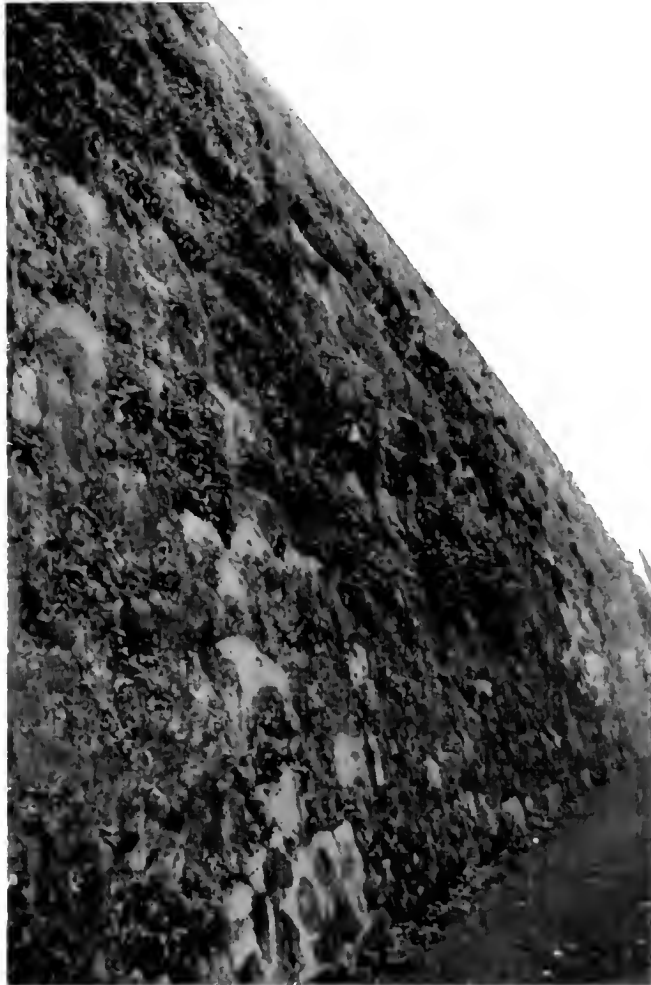
Figure 6: Extensive vegetation on San Juan Fortification Walls

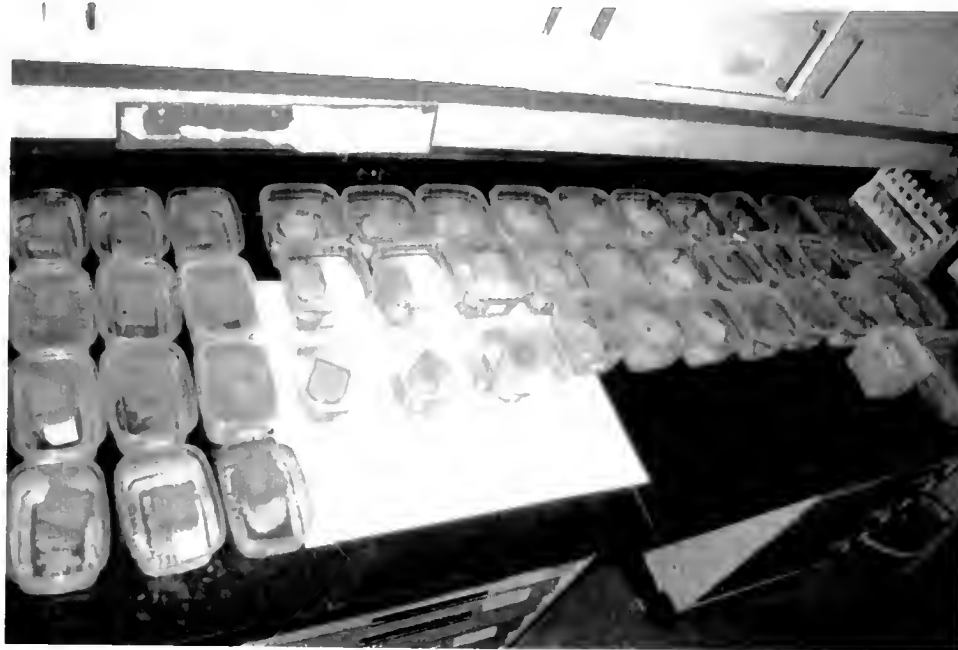
Figure 8: Immersion of samples

concentrated Round-up® herbicide mixed with tap water to the manufacturer's recommendations making a solution of 17% Round-up® in water. The fourth solution was Round-up® mixed with tap water to a concentration double the manufacturer's recommendations to increase the speed and intensity of reaction (34% solution of Round-up® to water). While Round-up® has been proven

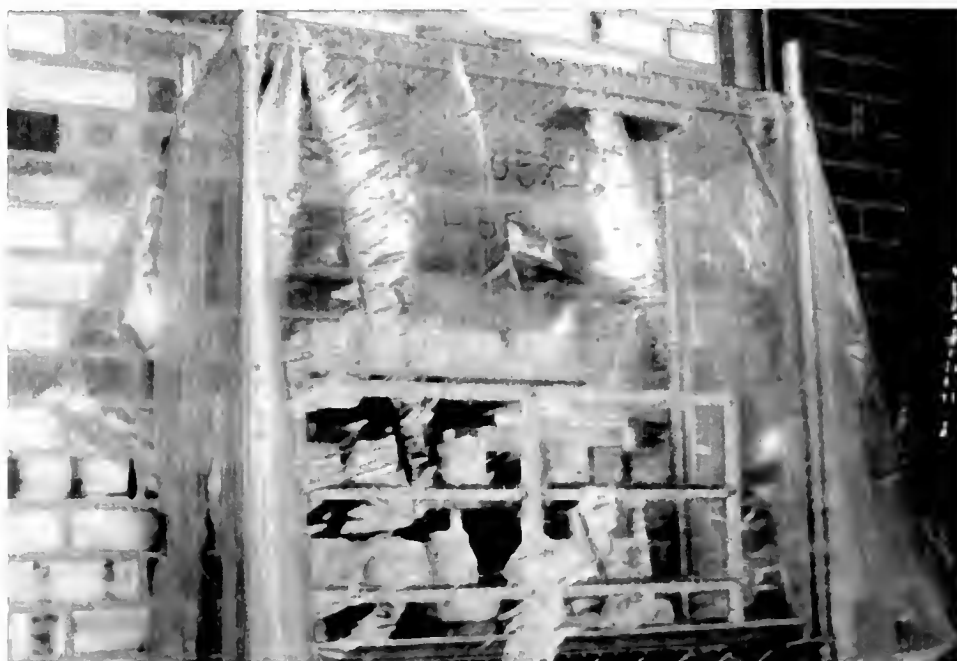
Figure 9: Samples drying outside

To simulate more realistic conditions, the stones were air-dried outside the Architectural Conservation Laboratory at the University of Pennsylvania. The

temperature ranged from 18°C to 32°C and the average relative humidity in June was about 64%. A protective chamber using a plastic drop cloth was designed to protect the samples from inclement weather.

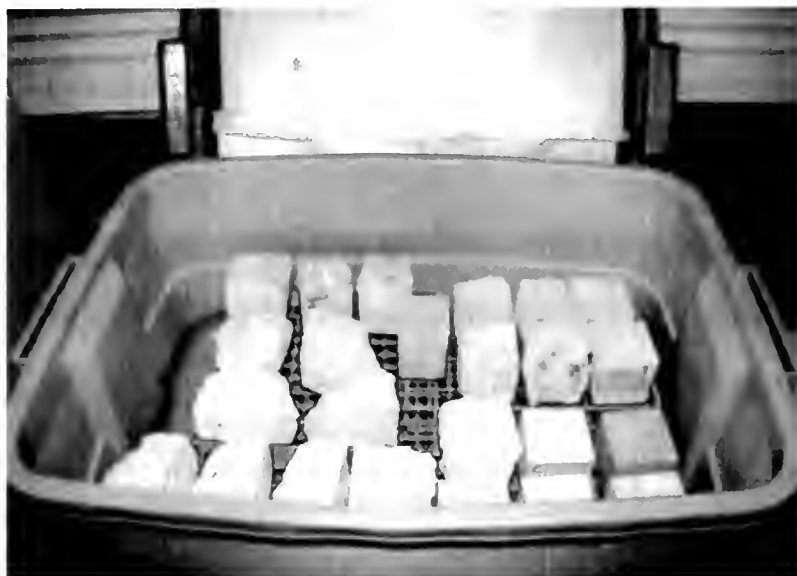
Figure 10: Stones in 100% Relative Humidity Chamber

Additional tests included hygroscopicity measurements to determine if the use of an herbicide would increase the attraction between water vapor and the stone. Hygroscopicity is the ability of a stone to absorb water vapor from the surrounding air. The porosity and water absorption capacity can affect the ability of the stone to absorb water vapor. The presence of soluble salts can also affect the hygroscopicity. After reaching a constant weight, the stones were placed on

racks in a plastic tub with 3.5cm of water in the bottom to create an environment of 100% relative humidity. The lid of the tub was covered with paper towels to absorb condensation and to prevent it from falling onto the samples. The tub was then sealed with duct tape. The samples were weighed weekly to measure the water adsorbed.

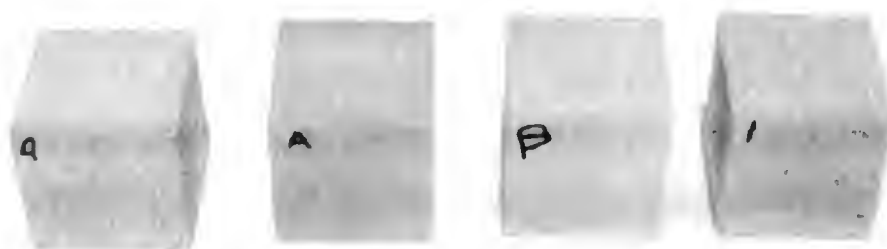
Figure 11: Indiana limestone from left to right: immersed in tap water (1), surfactant solution (A), 17% herbicide solution (b) and 34% herbicide solution (1)

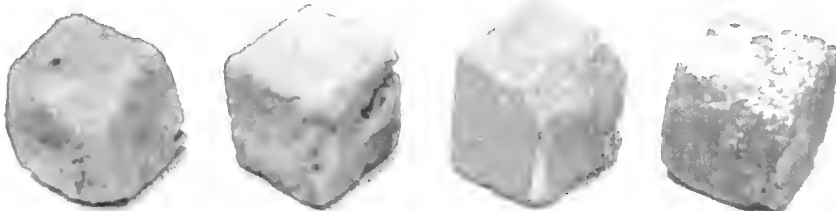
Figure 12: Fort Union brick from left to right: immersed in tap water (I), surfactant solution (A), 17% herbicide solution (a) and 34% herbicide solution (2)

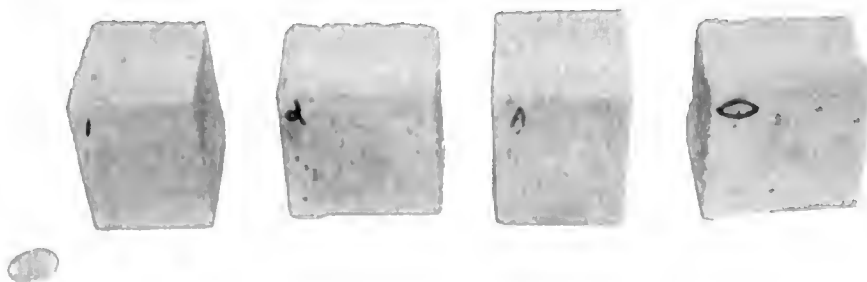
Figure 13: New brick from left to right: immersed in 34% herbicide solution (1), 17% herbicide solution (a), surfactant solution (A), and tap water (R)

There was little visual change in the new brick. No visible salt crystals formed. A salt haze appeared over portions of the bricks immersed in the herbicide solutions. Calcium carbonate particles in the brick powdered after immersion in the herbicide. The surface on the fireskin felt slightly smoother, a result of minor surface loss. There was no visible color change.

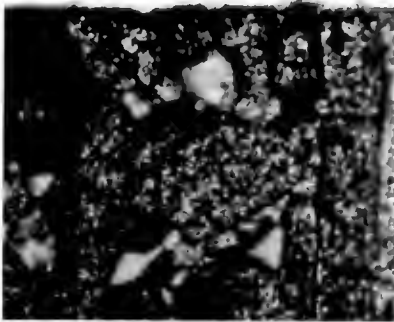
Figure 14: Surface of Indiana Limestone immersed water

In petrographic examination, the limestone was also noticeably affected by the different solutions. All samples, even those immersed in tap water, showed an increase in the amount of visible pores in the matrix. Small amounts of material were lost while soaking in tap water and the surfactant solution. Larger amounts of lost material were seen in the samples immersed in the 34% solution, which can, once again be attributed to the acidic glyphosate. When

comparing the two surfaces from the limestone sample immersed in the tap water and the limestone sample immersed in the 34% solution of herbicide, it is clear that there was significant surface loss.

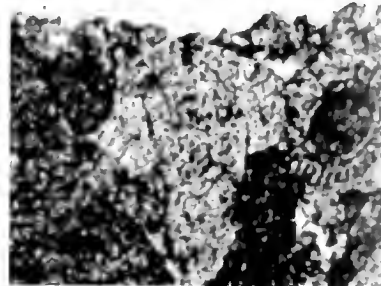
Figure 15: Surface of Indiana Limestone immersed in 34% herbicide solution

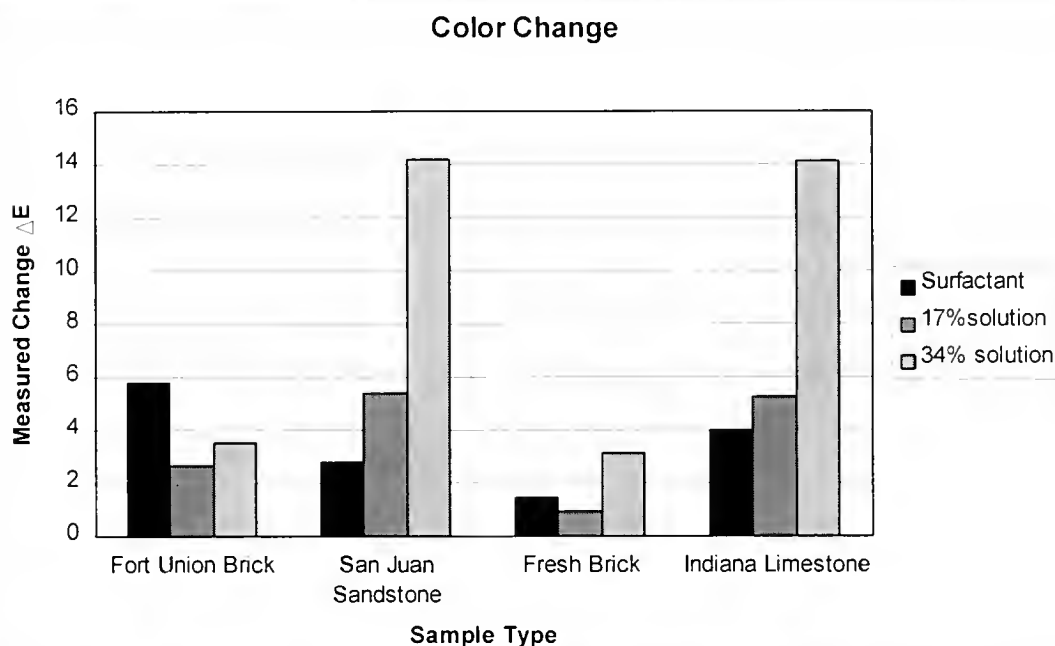
Figure 17: Color change in samples

The samples immersed in the tap water were used as the control for the color change measurements and are highlighted with gray on the chart. Minor color changes were detected in all the solutions with major color changes occurring in the 34% solution. A number recorded at 5 or above in the ΔE column indicates a clearly visible color change. Sample C from the Fort Union brick appears to be a color change but is not because a darker colored brick was originally used in the surfactant solution. The color changes seen are likely to be a function of the

low pH of glyphosate as evidenced by the author in an acid solubility test on similar samples.

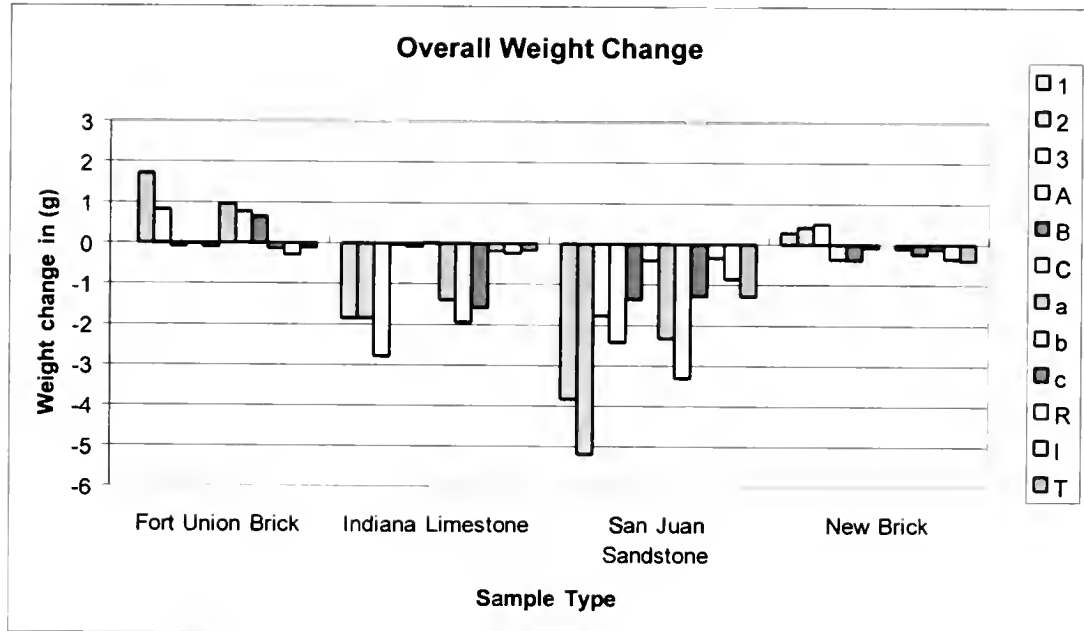
Figure 18: Graph illustrating overall weight change, note the weight loss of the sandstone and the limestone

Overall, there was some weight change in all the samples. The samples were weighed before and after treatment. Residual material remained in the solution containers from the samples and from the formation of the insoluble calcium complex that is characteristic of glyphosate. By subtracting the weight (post-treatment) from the weight (pre-treatment) and then subtracting the weight of the residue, a total weight change was determined.

Both the San Juan sandstone and the Indiana limestone showed loss in all solutions. This is due to the friable nature of the natural stone and its susceptibility to acid. The sandstone, a poorer quality stone, had the most significant weight loss. The Fort Union brick gained weight in the two herbicide solutions. This may be attributable to the excessive salt growth covering the sample. The weight of this brick may have been less affected by the herbicide because it is fired at high temperatures sintering the clay minerals with a stronger bond than that found in the natural stone. The herbicide had little effect on the fresh brick. All weight change of the new brick was calculated to less than a gram, a very insignificant amount. However, the fresh brick did gain a

amount of weight in the 34% solution which may be attributable to salt deposits. Detailed measurements may be found in Appendix C.

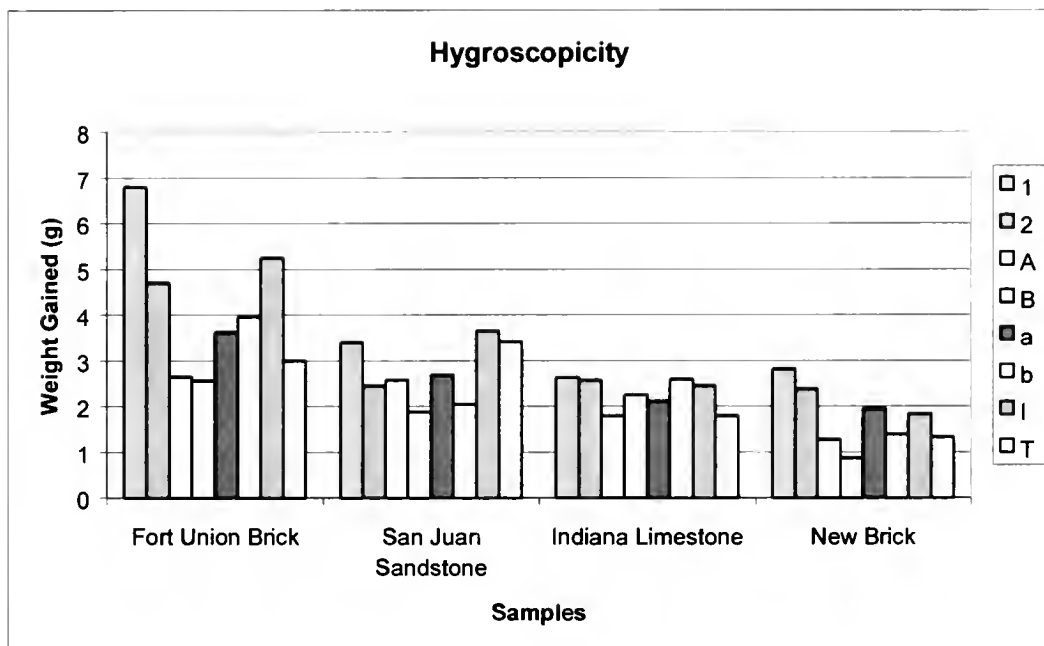
Figure 19: Chart illustrating hygroscopicity measurements of each sample tested

The stones immersed in the 34% herbicide solution were only slightly more hygroscopic than the tap water solutions. The herbicides immersed in the surfactant showed the least amount of water gain and the 17% solution samples were only slightly more hygroscopic than the surfactant samples. The most hygroscopic samples were the Fort Union bricks immersed in the 34% solution.

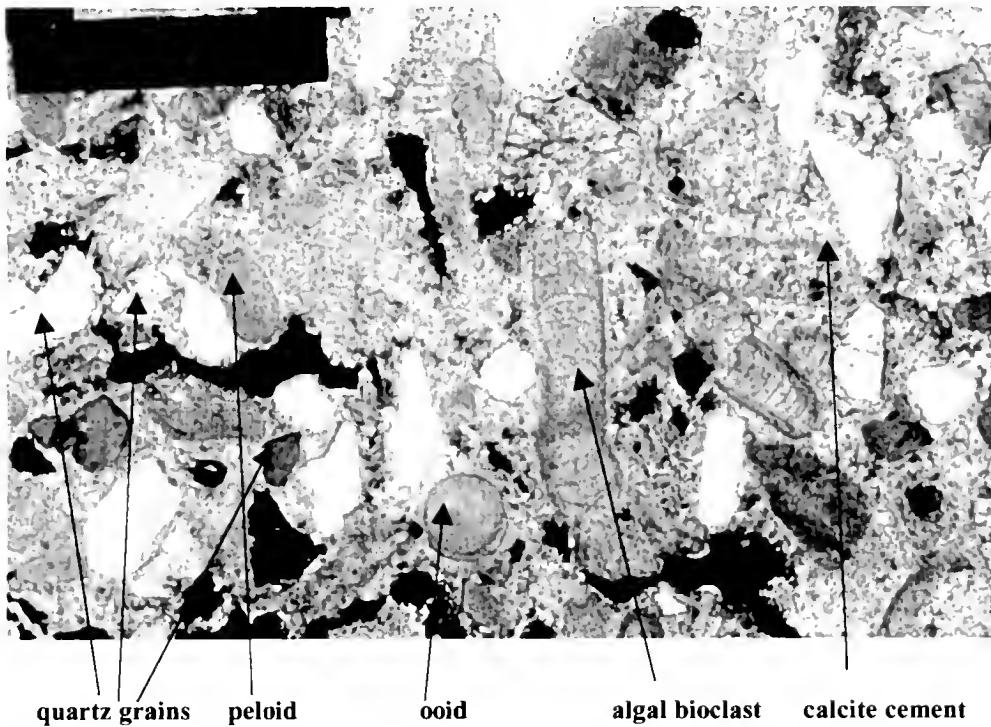
Figure 20: San Juan sandstone before treatment, 25X

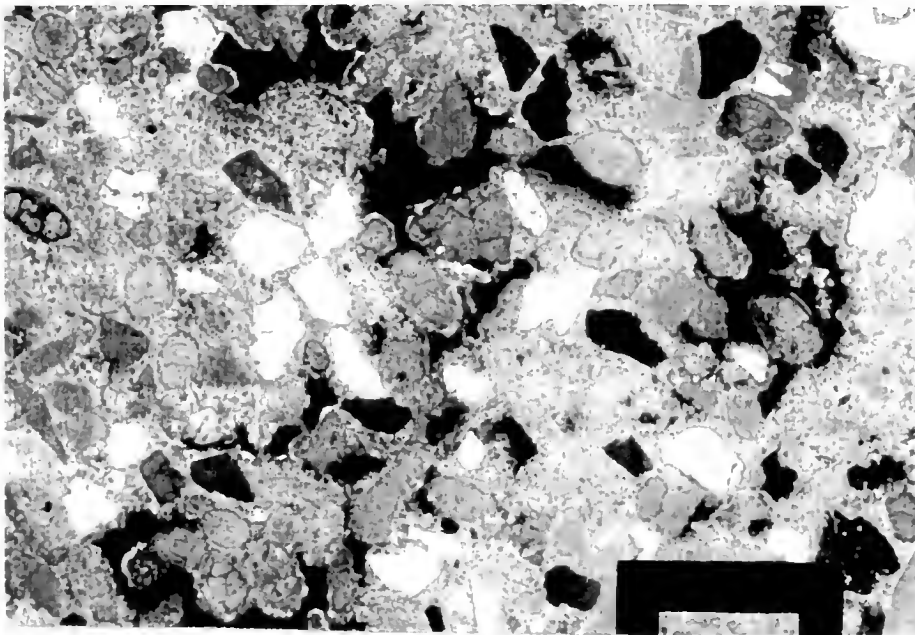
Figure 21: San Juan sandstone in tap water, 25x, Note increase in pore space and blue tinted salts

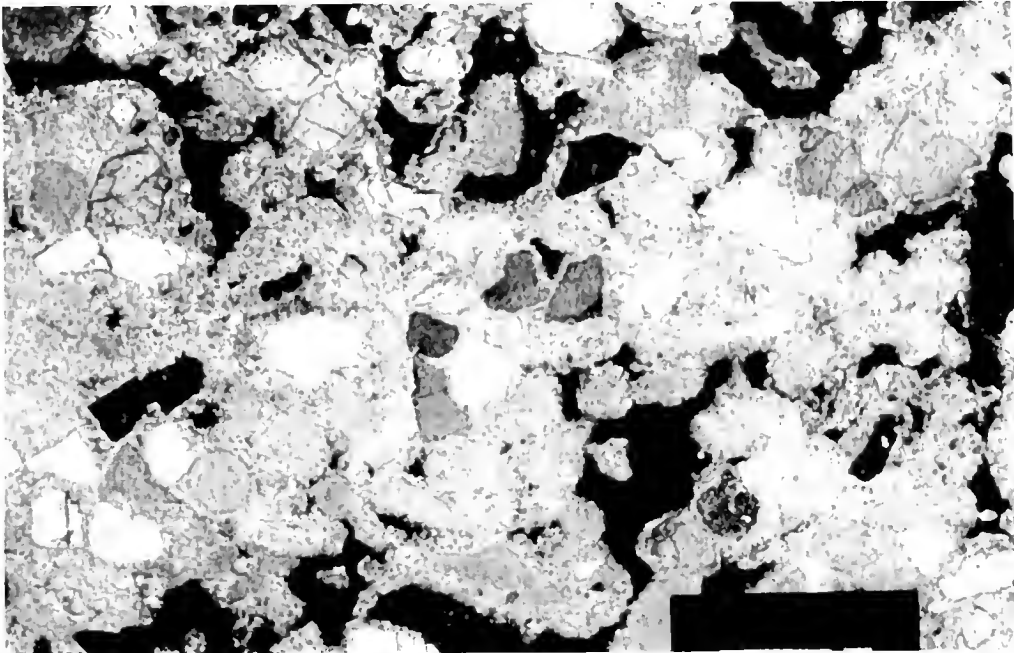
Figure 23: San Juan sandstone from surfactant solution, 25X, Note results similar to tap water solution

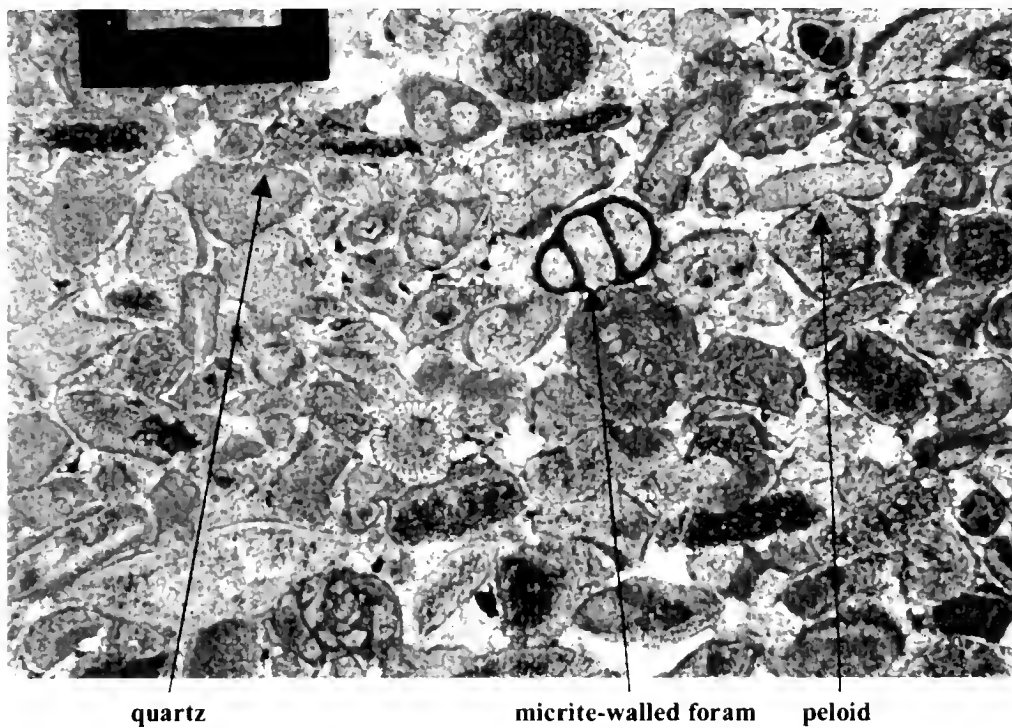
Figure 25: Indiana limestone before treatment, 25X, Note low number of pores and high quantity of allochems

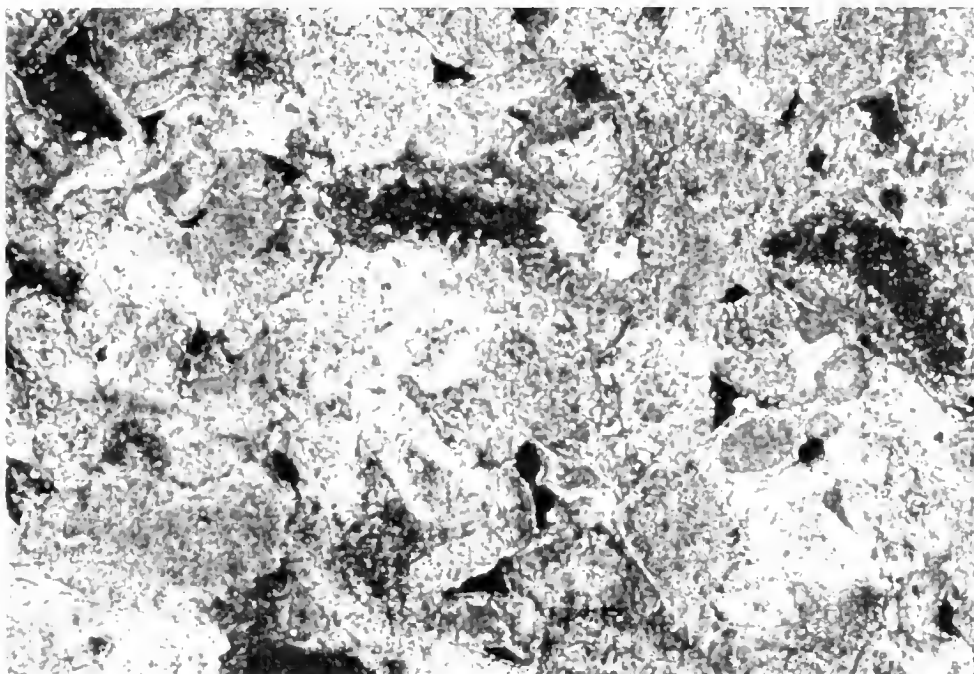
Figure 26: Indiana limestone immersed in tap water, 50X, Note increase in pore space

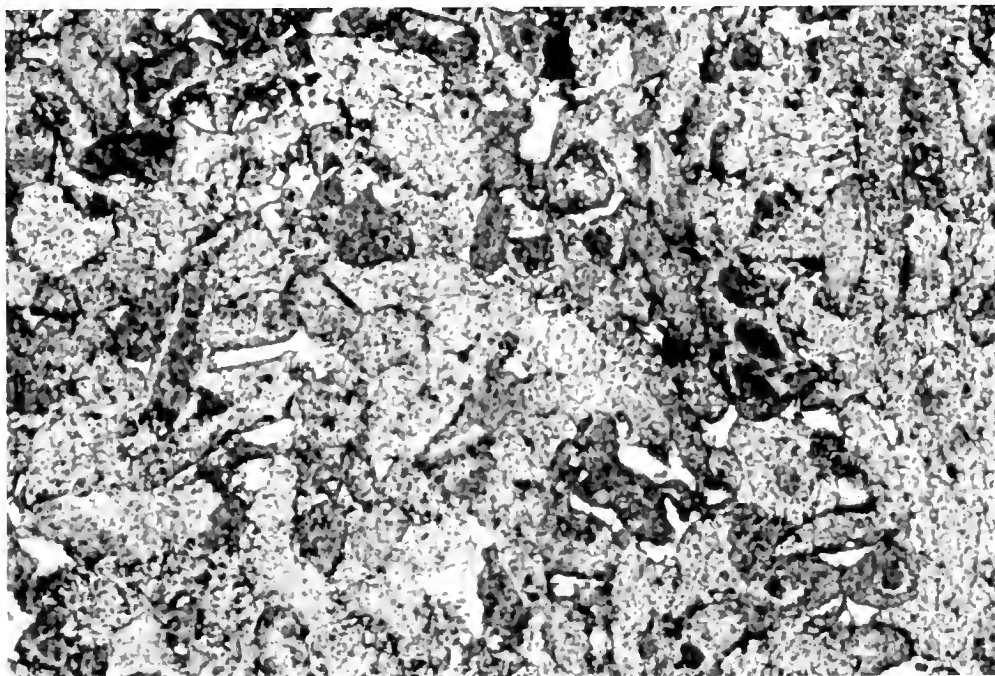
Figure 27: Indiana limestone immersed in surfactant solution, 50X, Note increase in pore space

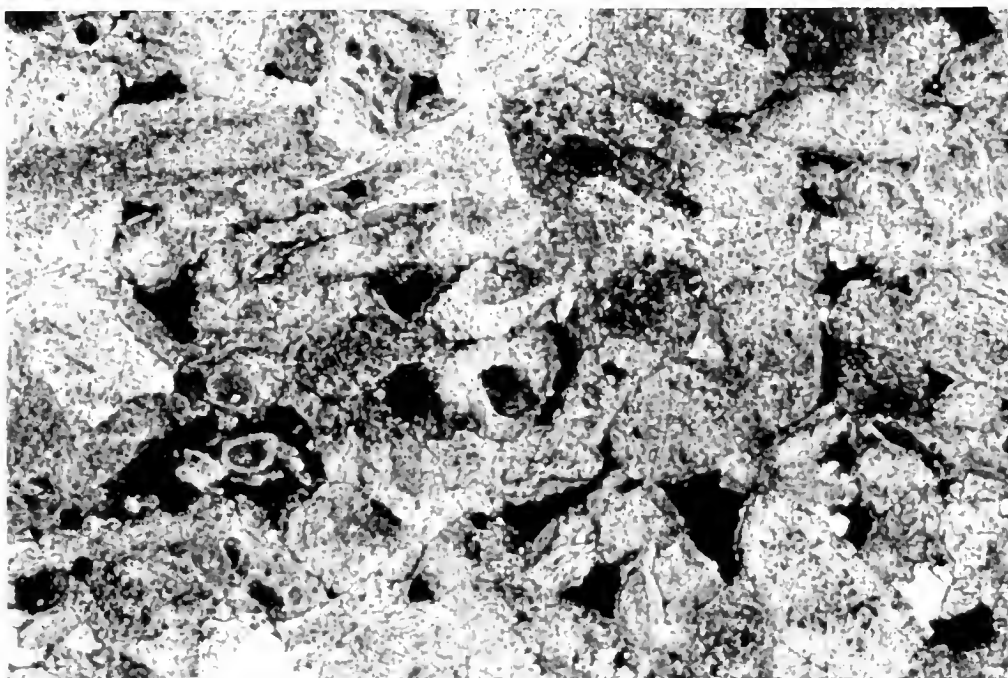
**Figure 28: Indiana limestone immersed in 34% herbicide solution, 50X,
Note loss of cement creating more pore space**

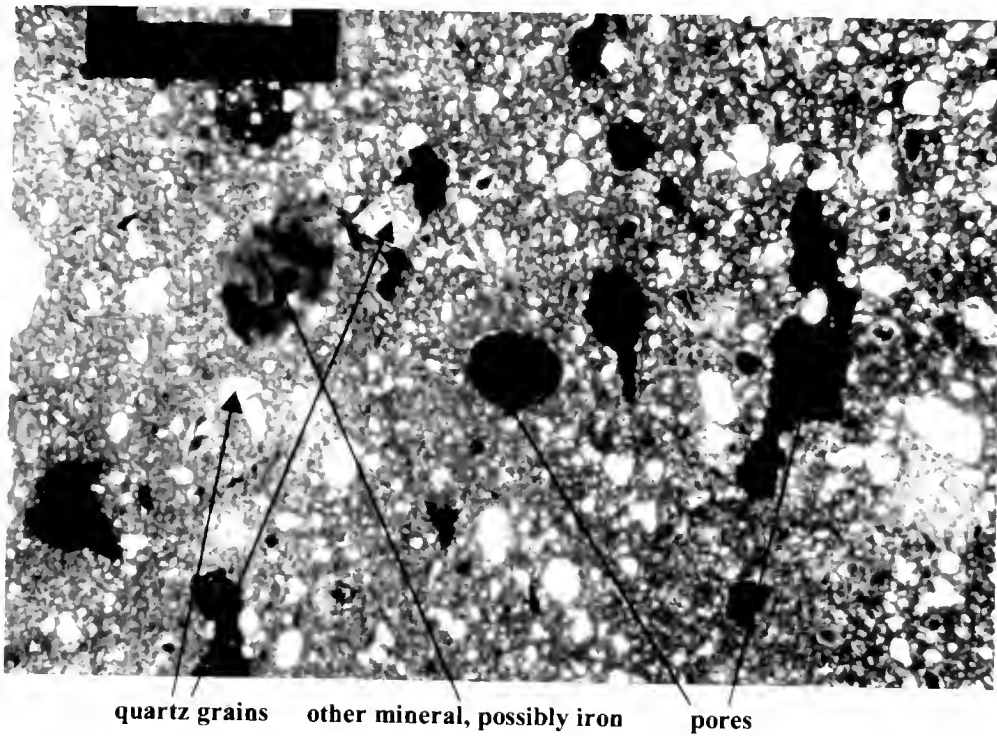
Figure 29: Fort Union brick before treatment, 25X

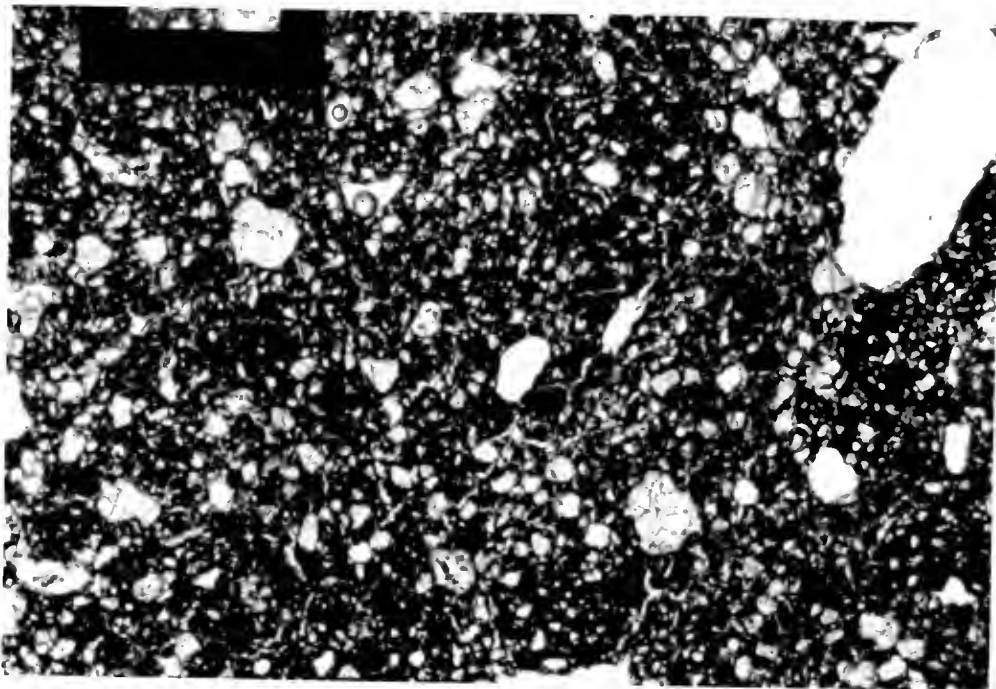
Figure 30: Fort Union brick immersed in tap water, 25X, Note small channels in clay matrix

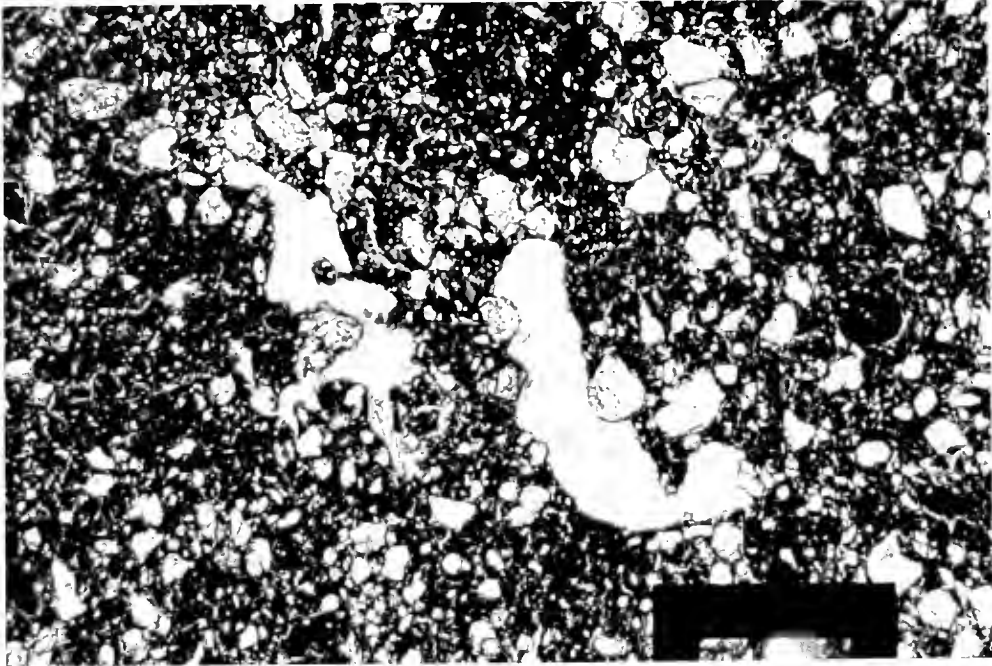
Figure 31: Fort Union Brick immersed in surfactant solution, 25X, Note small channels in clay matrix and pores similar to pre-treatment samples in size

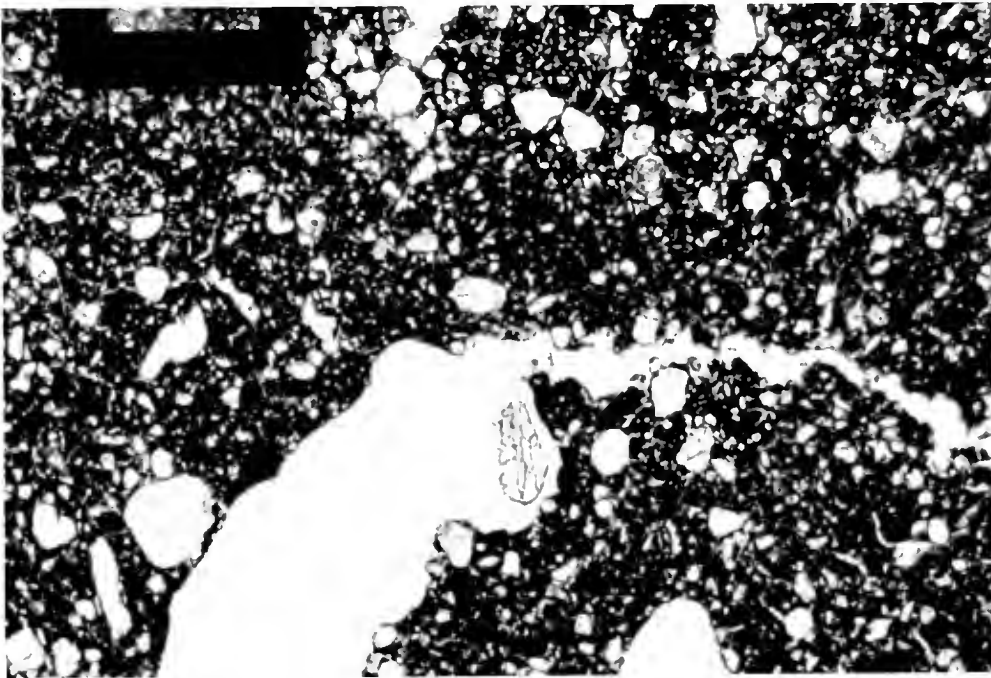
Figure 32: Fort Union brick immersed in 34% herbicide solution, 25X, Note formation of larger and smaller pores and channels

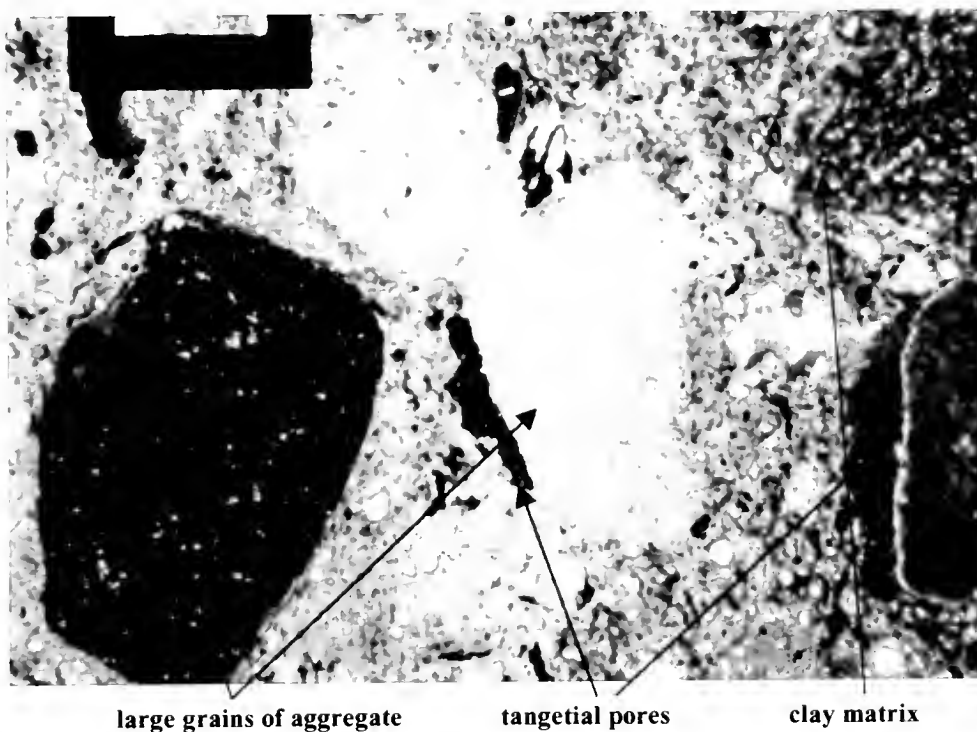
Figure 33: New brick before treatment, 25X

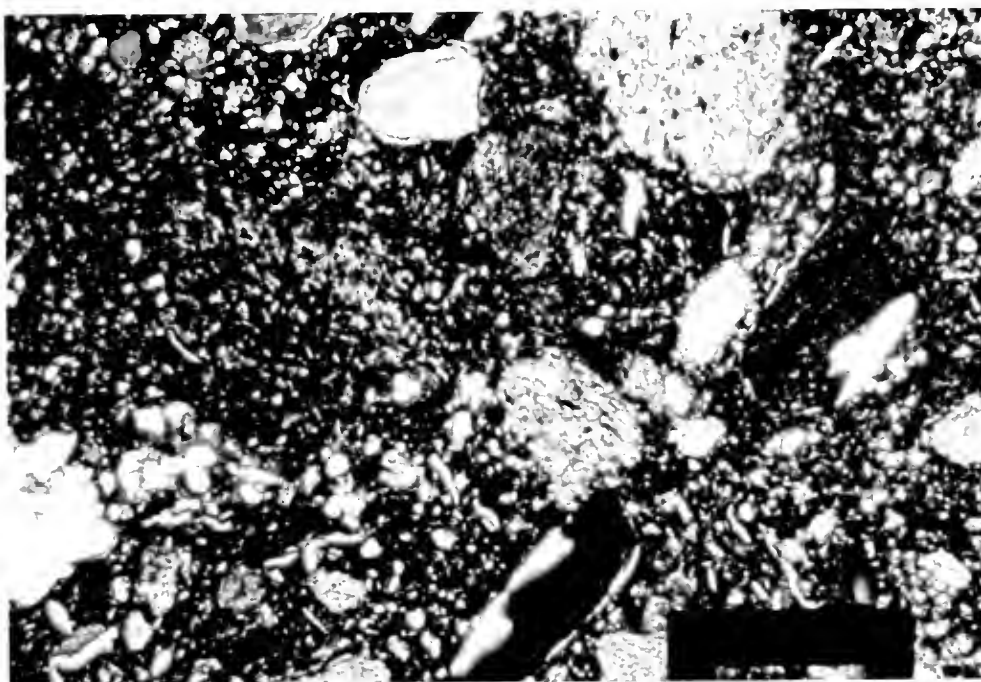
Figure 34: New brick immersed in 34% herbicide solution, 25X, Note little change in structure
